PIPELINE

6" HDD FIELD TEST THRU ROCKY TERRAIN

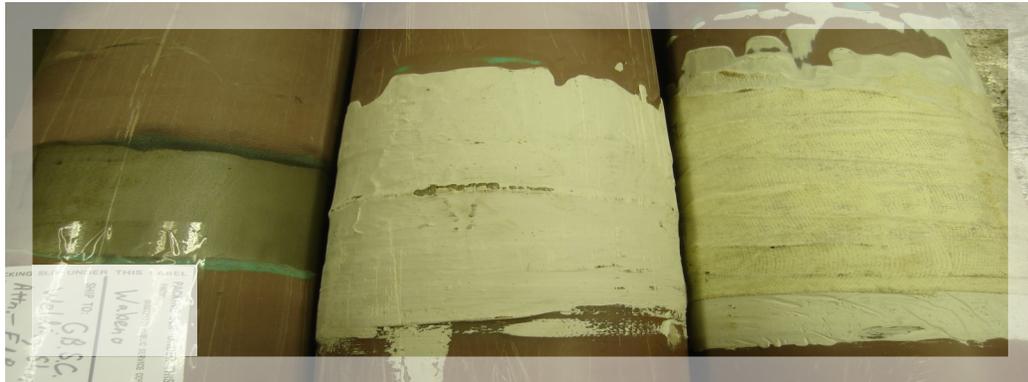
After installing all 3 systems, the crew welded an additional stick of pipe behind the bore head to allow for visual inspection of the trial. When the systems had set, it was time for the crew to began the pull-back, thrusting the pipe through the impacted, rocky soil. Everyone waited anxiously to observe the results.

- 1) The visual inspection revealed that the rough terrain completely removed the cold applied tape.
- 2) Although the two-part epoxy was specifically designed for the abrasion and impact associated with directional drilling, the height of the weld took the brunt of the force chipping the epoxy down to bare steel and creating holidays.
- 3) The final system the included 4 layers of Scar-Guard SYS, protected the corrosion coating flawlessly! The company determined that Scar-Guard's composite-reinforced resin technology was the answer.
