SCAR-GUARD™

26" CRUDE PIPELINE CONSTRUCTION

SAUDI ARABIA, AUGUST 2013

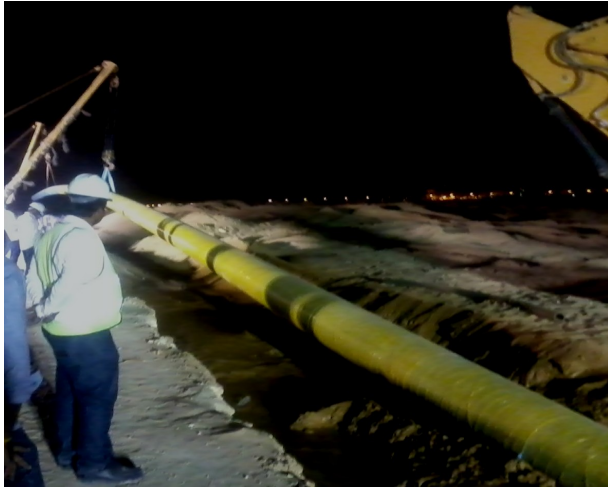
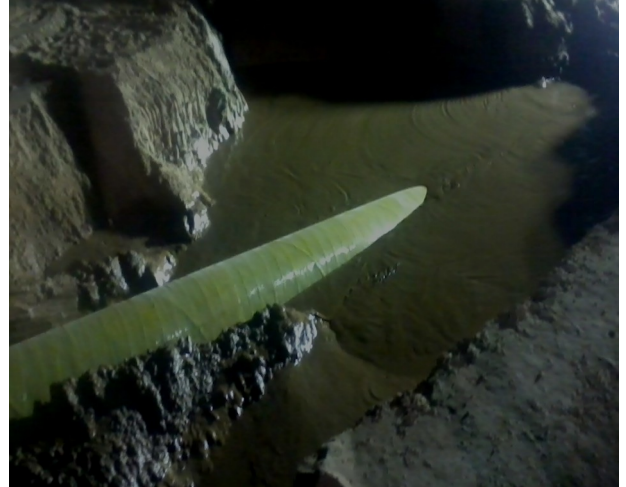
The Scar-Guard™ System was installed prior to the pull back of the 26" OD pipeline to protect the factory-applied FBE coating and the girth-welded field joints from the abrasion stresses and scarring associated with the horizontal directional drilling process. The Scar-Guard system provides mechanical protection to the approved, manufacturer-applied, FBE corrosion coating, resulting in a very low profile, extremely conformable, and highly impact-resistant composite-reinforced coating which encapsulates and protects the entire length of new pipe during the harsh pull back process.

The contractor on the project successfully installed the Scar-Guard system over 160 linear feet (49m) of 26" diameter pipe ahead-of-schedule, protecting the integrity of the underlying FBE coating, while also providing accost-effective and time-saving solution. The project was a great success and neither the pipe nor the original coating was damaged during the HDD pull back process.
