# SCAR-GUARD™

## (36) 36" OD BELL AND SPIGOT JOINTS

USA, MAY 2011

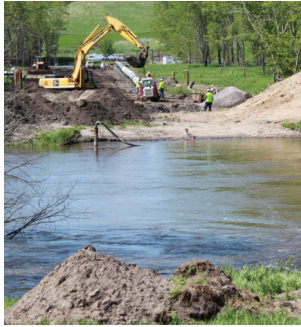
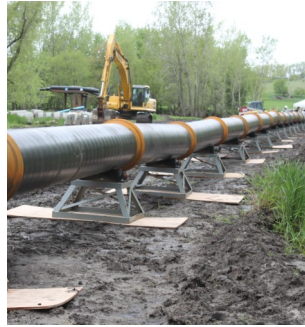
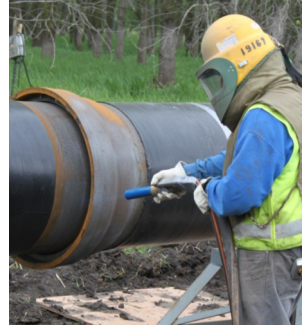
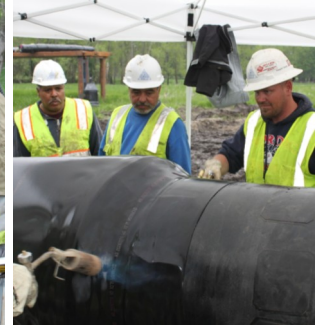
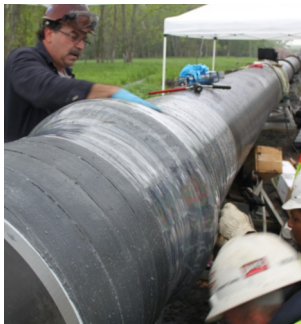
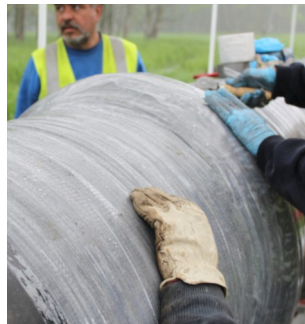
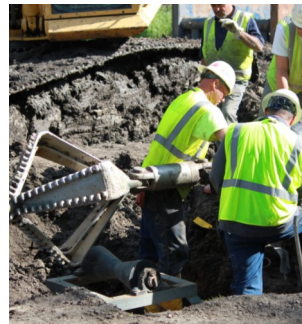
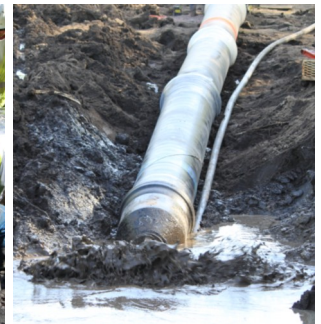
The joints were first coated with a primer, then with a high-recovery sleeve manufactured by Canusa, a Shawcor company, prior to the installation of the Scar-Guard™. After applying the Canusa shrink sleeve, the crew applied 12 layers of Scar-Guard, which provided mechanical protection against abrasion during the pull through. Both the Canusa sleeve and Scar-Guard outer wrap were quickly hand-applied. Scar-Guard's fast curing resin system kept the job rolling.

Scar-Guard provided the added protection to safeguard the pipe and the job. The Scar-Guard system survived the pull-back fully intact.
